Tree Assessment  
For Median Trees  
Van Ness & Weldon Avenues  
City of Fresno

City of Fresno, Public Works  
2101 'G' St., Building E1  
Fresno, CA 93706

John Pape, ISA Certified Arborist  
Kuhtz Pape Consulting, LLC  
PO Box 8672  
Fresno, CA 93747

September 5, 2015

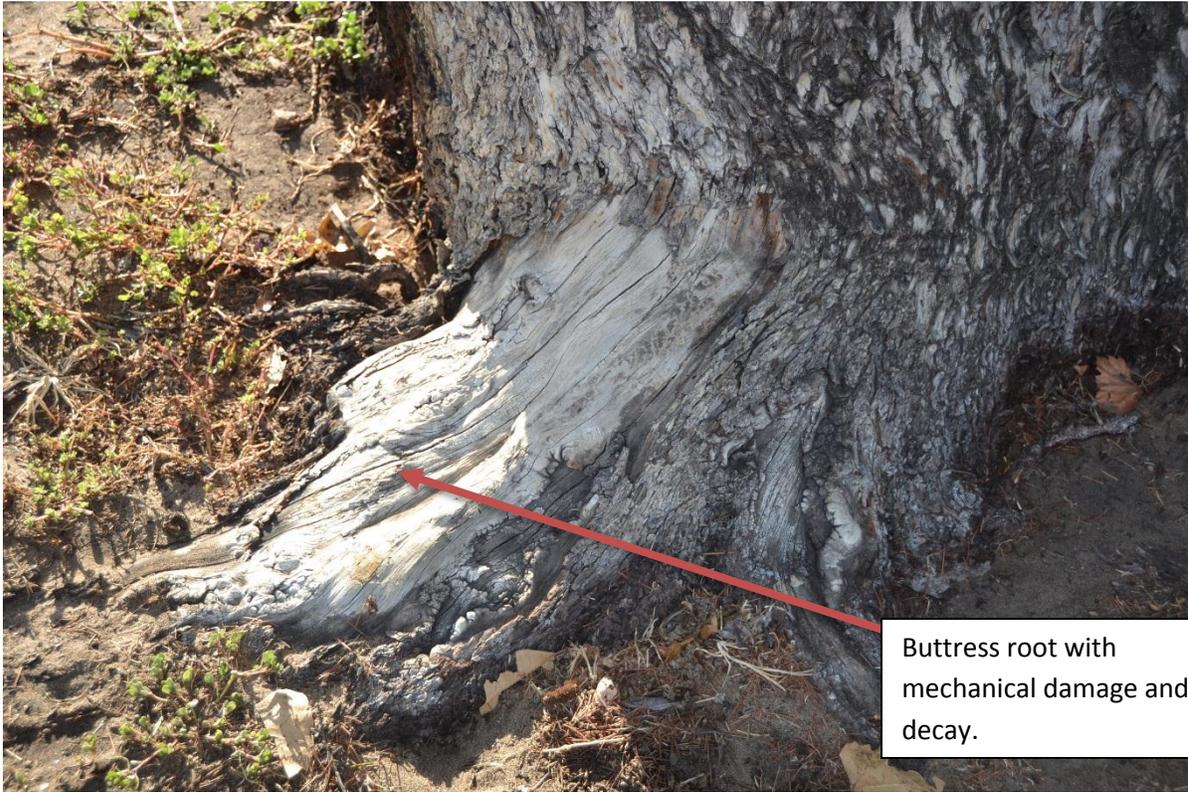
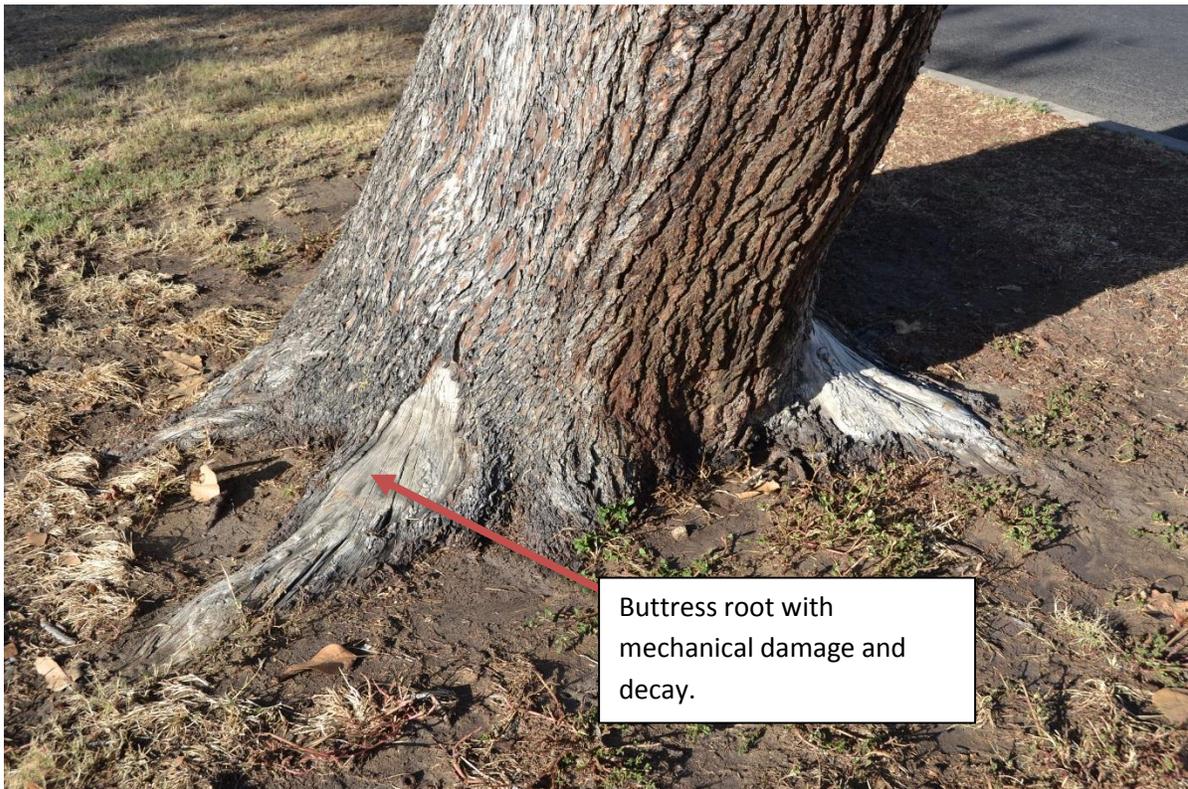
- A. The second tree south of Shields Avenue has substantial damage to its buttress roots, and is in poor condition. (See Appendix A – Photos 1 & 2)
- B. The third tree south of Shields Avenue has moderate damage to its buttress roots, and has yellowing and slowing growth in the upper portion of the tree. (See Appendix A – Photos 3 & 4)

- A. The second tree south of Shields Avenue – treat the soil with a soil drench application within the tree's drip line with a potassium-phosphite product, such as Actagro Resist, according to label directions.
- B. The third tree south of Shields Avenue – treat the soil with a soil drench application within the tree's drip line with a potassium-phosphite product, such as Actagro Resist, according to label directions.
- C. The second tree south of Simpson - treat the soil with a soil drench application within the tree's drip line with a potassium-phosphite product, such as Actagro Resist, according to label directions.
- D. The first tree south of Cornell Avenue - Remove the tree within 60 days for safety, and replace.

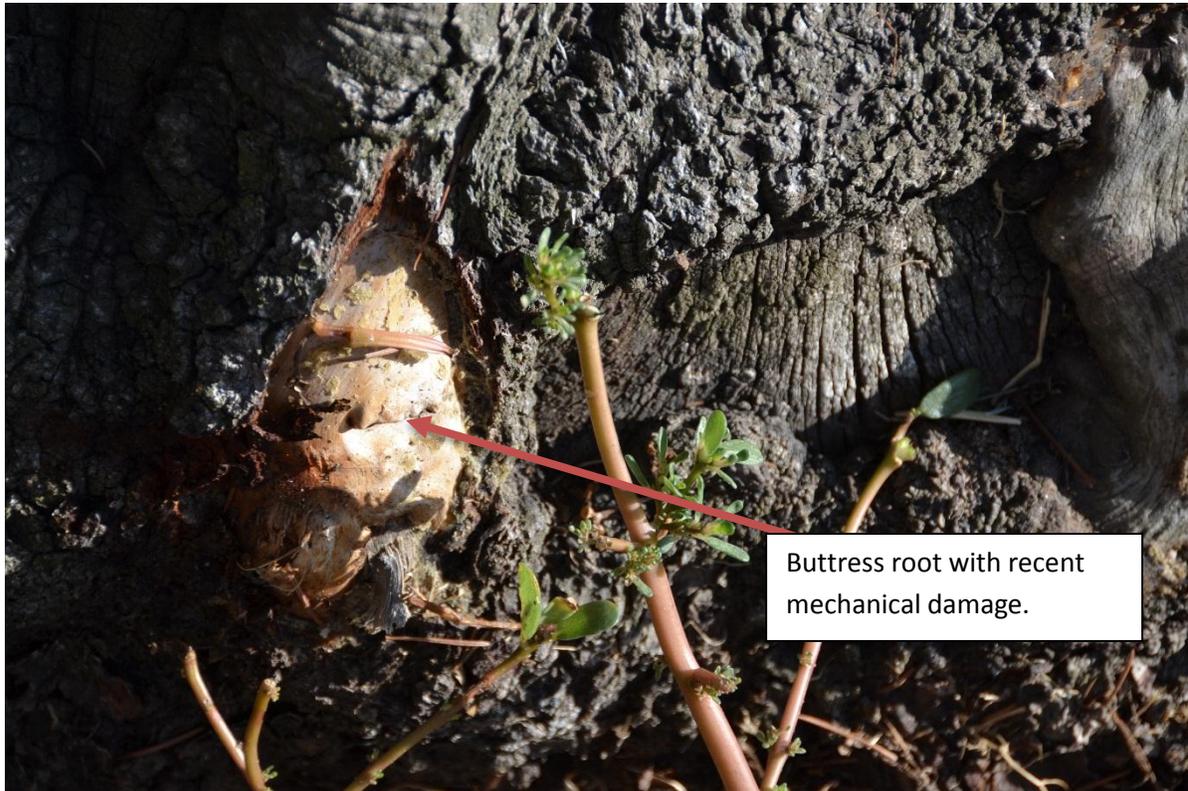
Photo 5

- C. The second tree south of Simpson Avenue has substantial damage to its buttress roots, and is in poor condition. (See Appendix A – Photos 5)
- D. The first tree south of Cornell Avenue has severe damage, and appears to have lost 60%-70% of its roots. (See Appendix A – Photo 6)

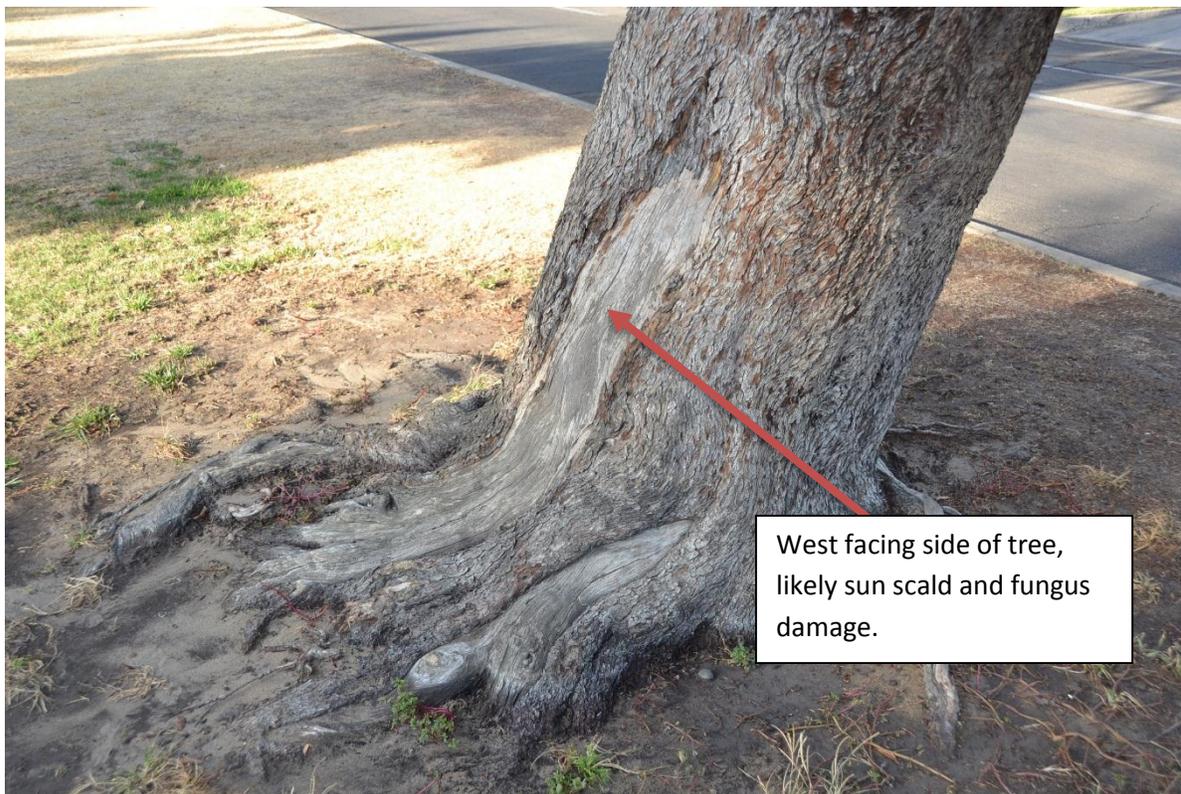
Photo 7

- E. The second tree south of Cornell Avenue has moderate damage to its buttress roots, lost branches, and has yellowing and slowing upper growth. It shows signs of positive regrowth. (See Appendix A – Photo 7)

- E. The second tree south of Cornell Avenue - treat the soil with a soil drench application within the tree's drip line with a potassium-phosphite product, such as Actagro Resist, according to label directions.

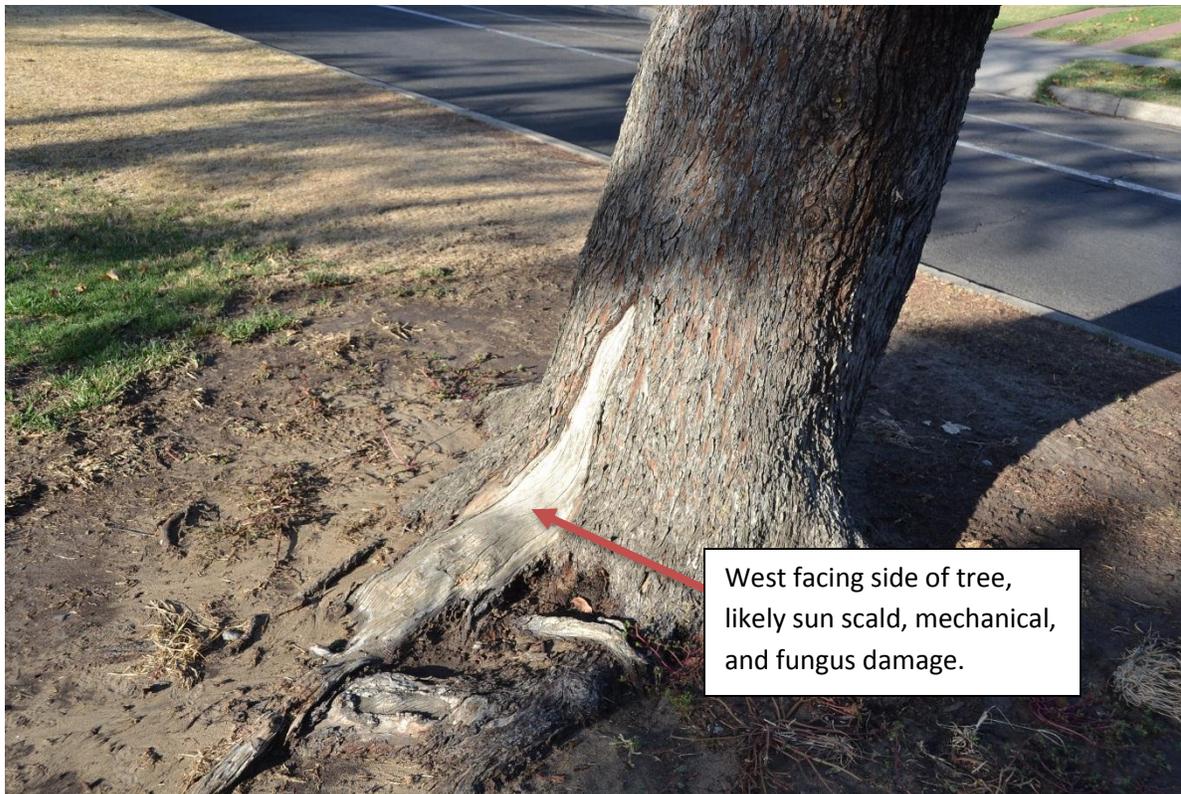
Photo 8

- F. The third tree south of Cornell Avenue has substantial damage to its buttress roots, and is in poor condition. (See Appendix A – Photo 8)
- G. The second tree south of Michigan Avenue is twisted and severely leaning with approximately 50% dead bark and roots. (See Appendix A – Photo 9)

- F. The third tree south of Cornell Avenue - treat the soil with a soil drench application within the tree's drip line with a potassium-phosphite product, such as Actagro Resist, according to label directions.

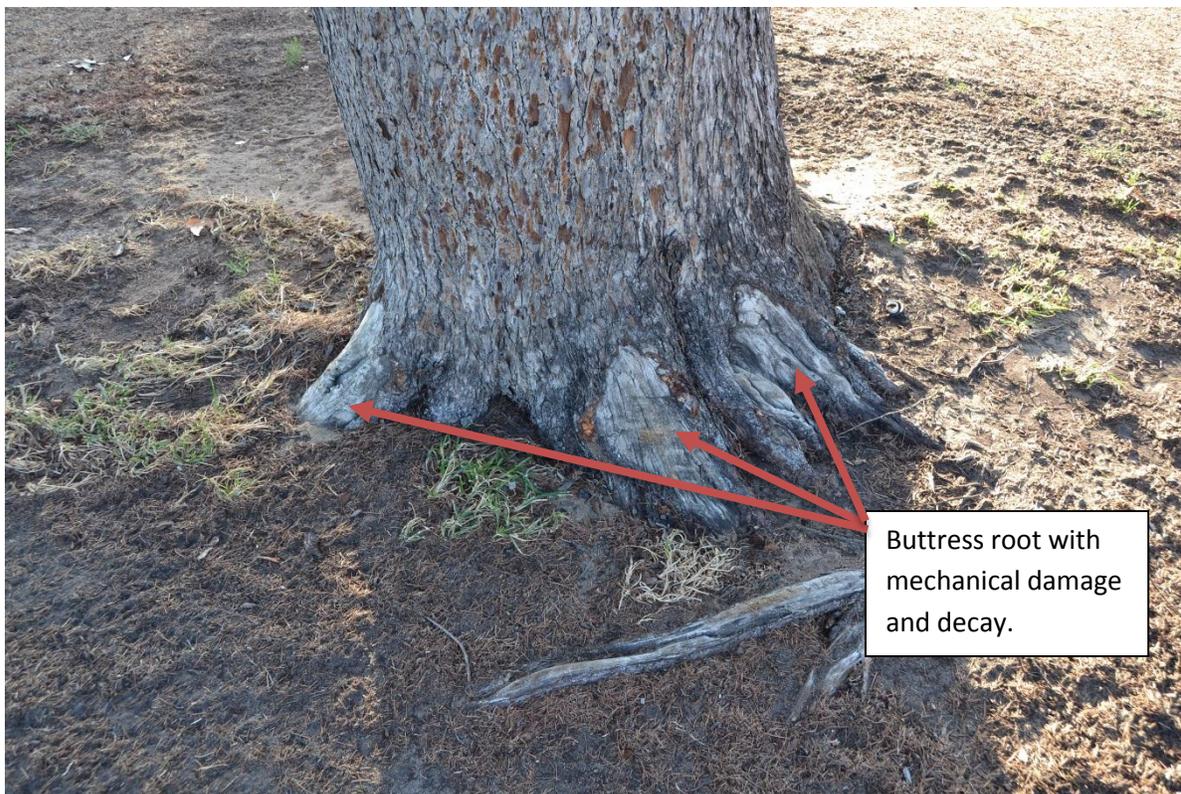
Photo 10

- H. The second tree south of Brown Avenue is very crooked and misshapen. (See Appendix A – No Photo)
- I. The second tree south of Vassar Avenue has substantial damage to its buttress roots, and is in poor condition. (See Appendix A – Photo 10)

- I. The second tree south of Vassar Avenue - treat the soil with a soil drench application within the tree's drip line with a potassium-phosphite product, such as Actagro Resist, according to label directions.

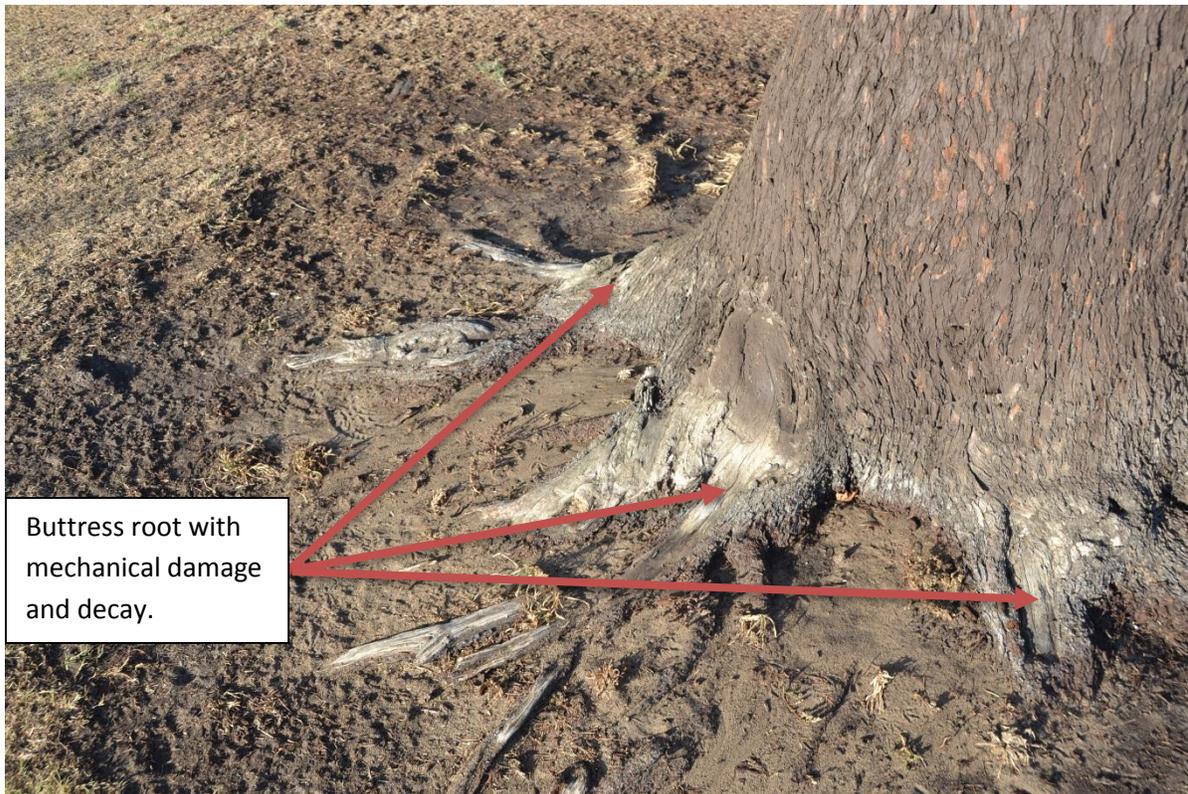
Photo 11

- J. The fourth tree south of Vassar Avenue has substantial damage to its buttress roots, and is in poor condition. (See Appendix A – Photo 11)
- K. The third tree south of Cambridge Avenue has very damaged **root flare** and too much of its central **leader** is dead. (See Appendix A – No Photo)

- J. The fourth tree south of Vassar Avenue - treat the soil with a soil drench application within the tree's drip line with a potassium-phosphite product, such as Actagro Resist, according to label directions.

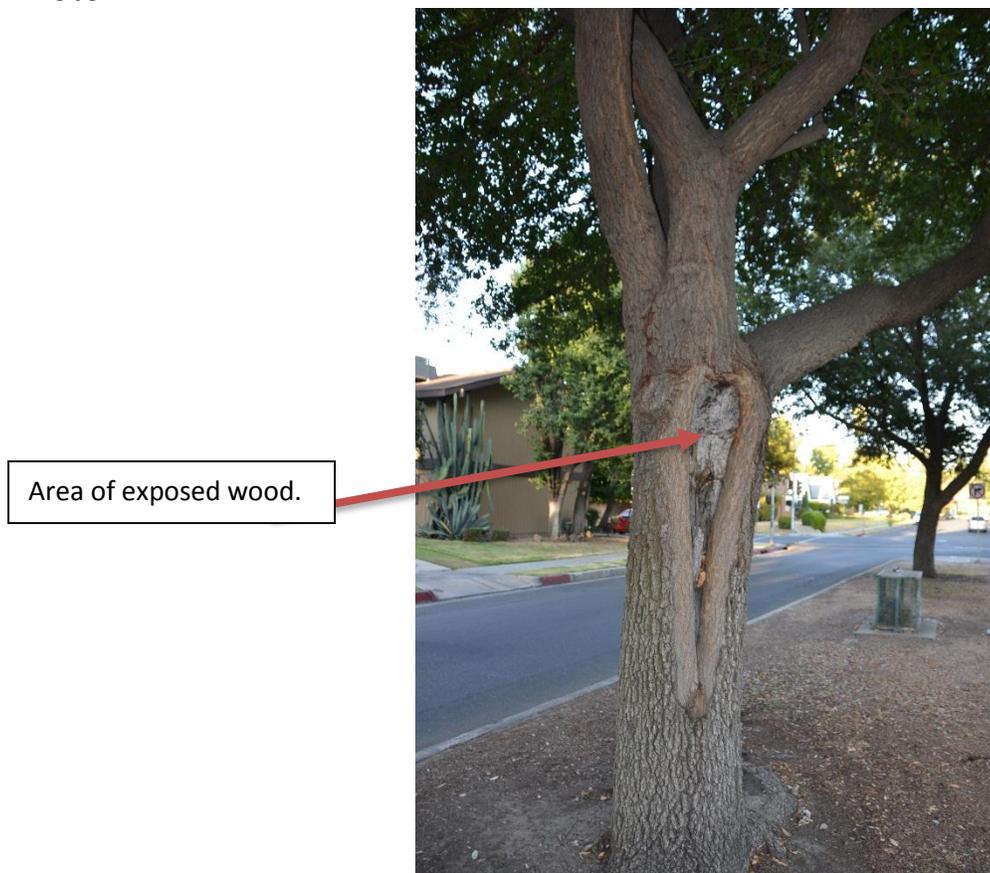
Photo 12

Only one tree has any significant health issues. The second tree west of Maroa Avenue has a large area of the main trunk missing on the southwest side, exposing the inner wood just below the base of the **scaffold branches**. (See Appendix A – Photo 12)

Of the 23 Southern Live Oaks 22 have become well established, and are in good condition. The second tree west of Maroa, has significant damage to its trunk at the base of the scaffold branches, which could threaten its health and structural integrity in the future.

For the second tree west of Maroa, treat the exposed wood of this trunk with an application of copper fungicide per label instructions to help slow wood decay.
